December 2013

Lower Duwamish Waterway 104(e) Review Checklist

Name of 104(e) Recipient Jorgensen Forge Corporation

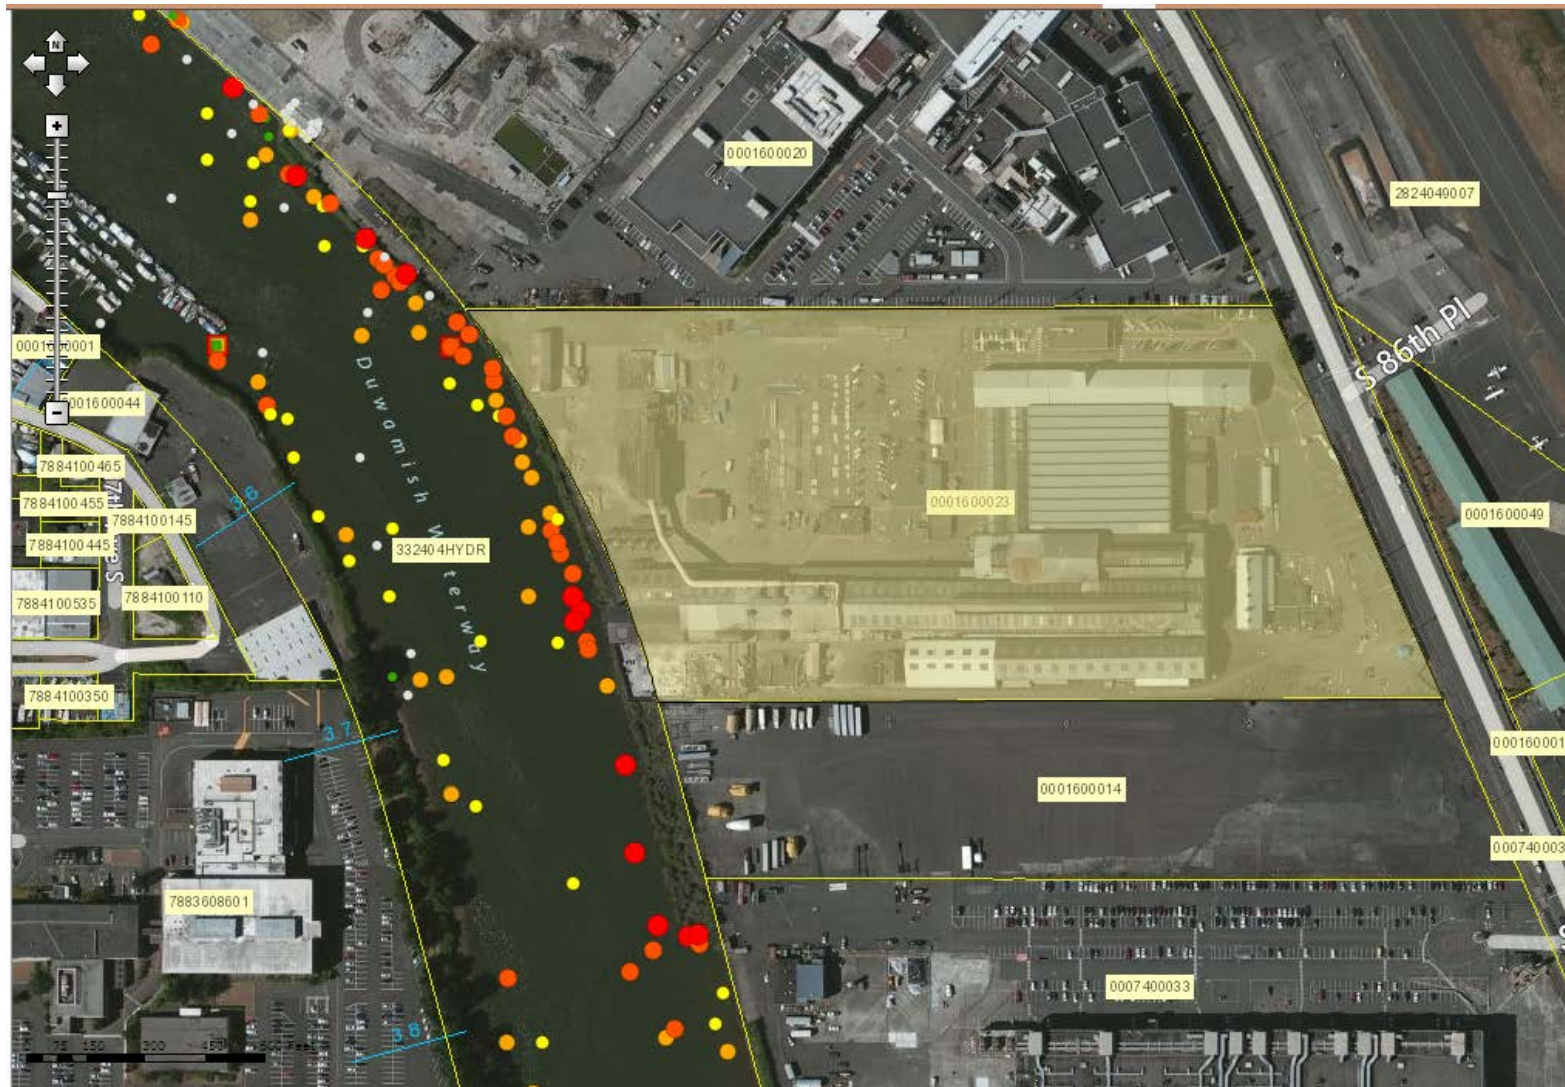
Jorgensen Forge Corporation - Parcel 0001600023
8531 East Marginal Way S
Seattle, WA 98134
Arsenic and Dioxins/Furans [LDW GIS Map]

According to the LDW GIS Map, arsenic (max: 481 ppm just south of the Jorgensen property line; SQS: 57 ppm), dioxins/furans, PCBs (max: 3700 ppm OC-Norm; SQS: 12 ppm), PAHs,

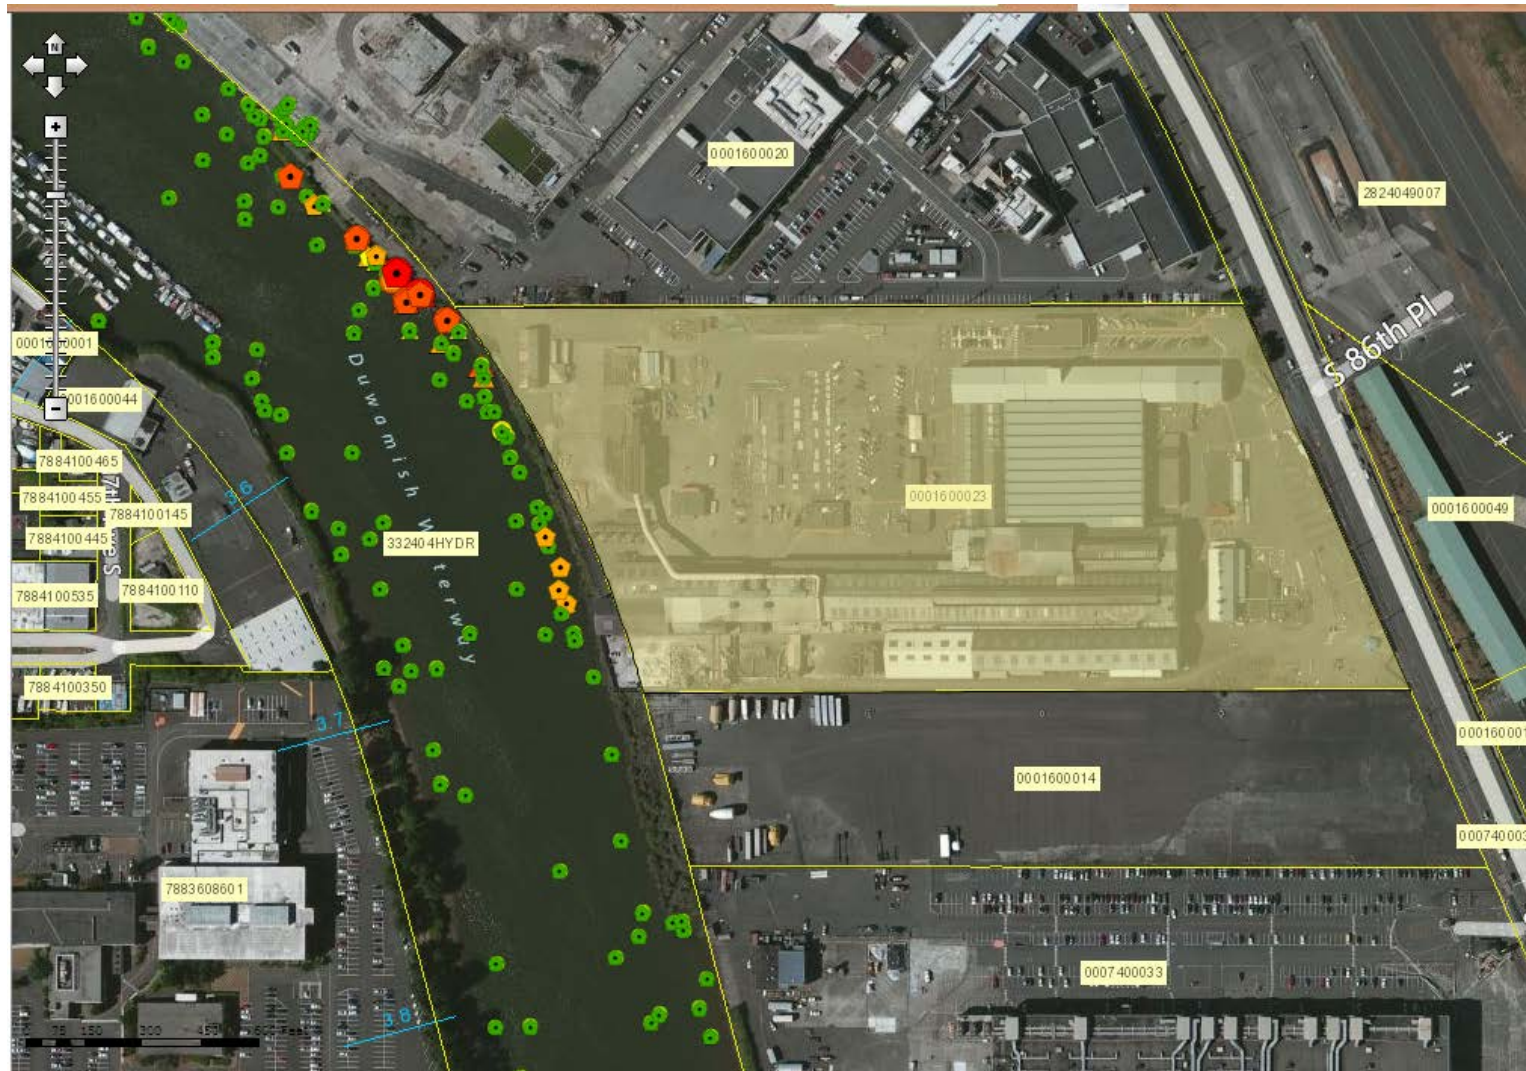
Jorgensen Forge Corporation - Parcel 0001600023
8531 East Marginal Way S
Seattle, WA 98134
Lead, Copper, and Zinc [LDW GIS Map]

lead (max: 3500 ppm, with 23,000 ppm just north of the property line; SQS: 450 ppm), copper (max: 2500, with 12000 ppm just north of the property line; SQS: 390 ppm), and zinc (3,500 ppm, with 9700 ppm just north of the property line; SQS: 410 ppm) all have been sampled at elevated levels or above the SQS in the sediments adjacent to the Jorgensen Forge parcel. There is no SQS with which to compare PAHs and dioxins/furans [LDW GIS Map].

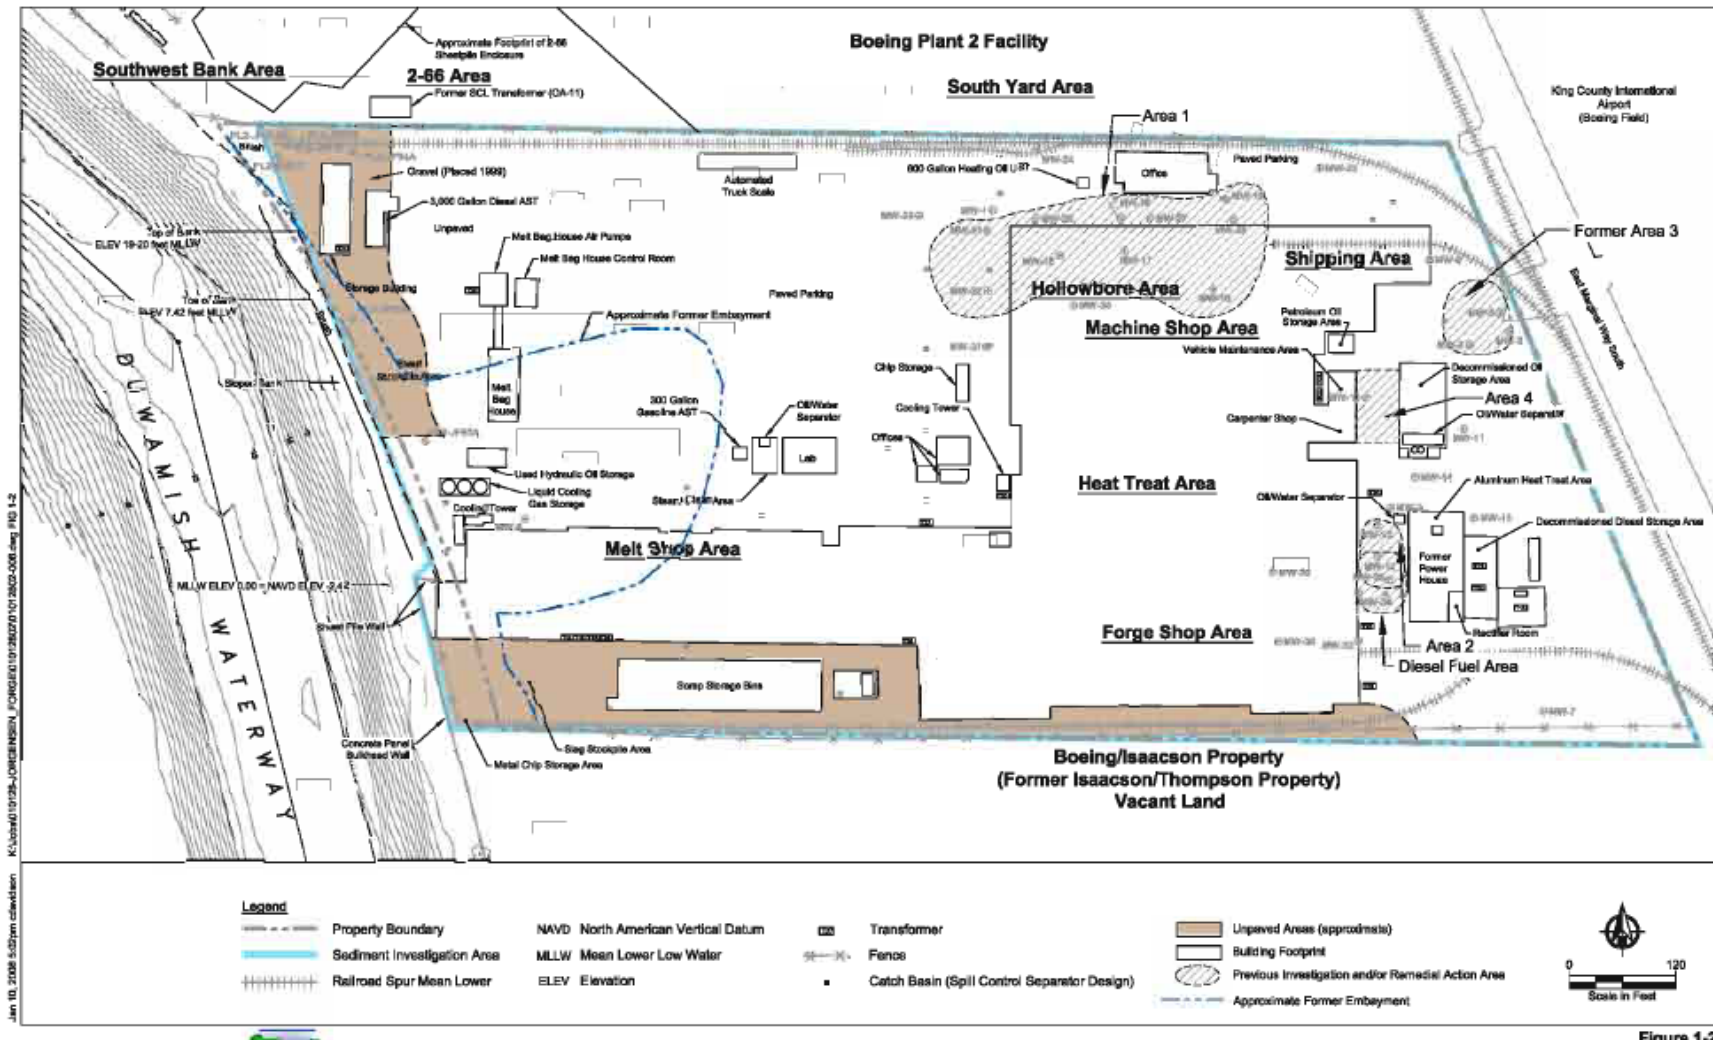
[SIA Map, 2008 Draft Source Control Evaluation Report, p. 267]

At some point between 1936 and 1946, fill was placed in a large embayment that was located on the western portion of the property. The source of the fill may be the result of historical hydraulic dredging conducted in the LDW by the Army Corp or unknown upland sources [Data Summary Report, 616091, p. 13; Aerial photographs, 626781]. *See Figure SIA Map.*

Fill was placed at the property between 1942 and 1946 to fill in the former embayment. This fill has been identified as one potential source of PCB and metals contamination. The source of the fill may have been historical hydraulic dredging conducted in the LDW by the ACOE or from unknown upland sources [Final Investigation Data Summary, 616091, p. 20]. *See Figure SIA Map.*

- Area 1 Hollowbore area
- Area 2 Oil/Water separator
- Area 3 Former UST locations
- Area 4 West of Decommissioned Oil Storage Area
- Diesel Fuel Area - West of Aluminum Heat Treat Building [PRP Summary 0001600023, p. 12]. *See Figure SIA Map.*

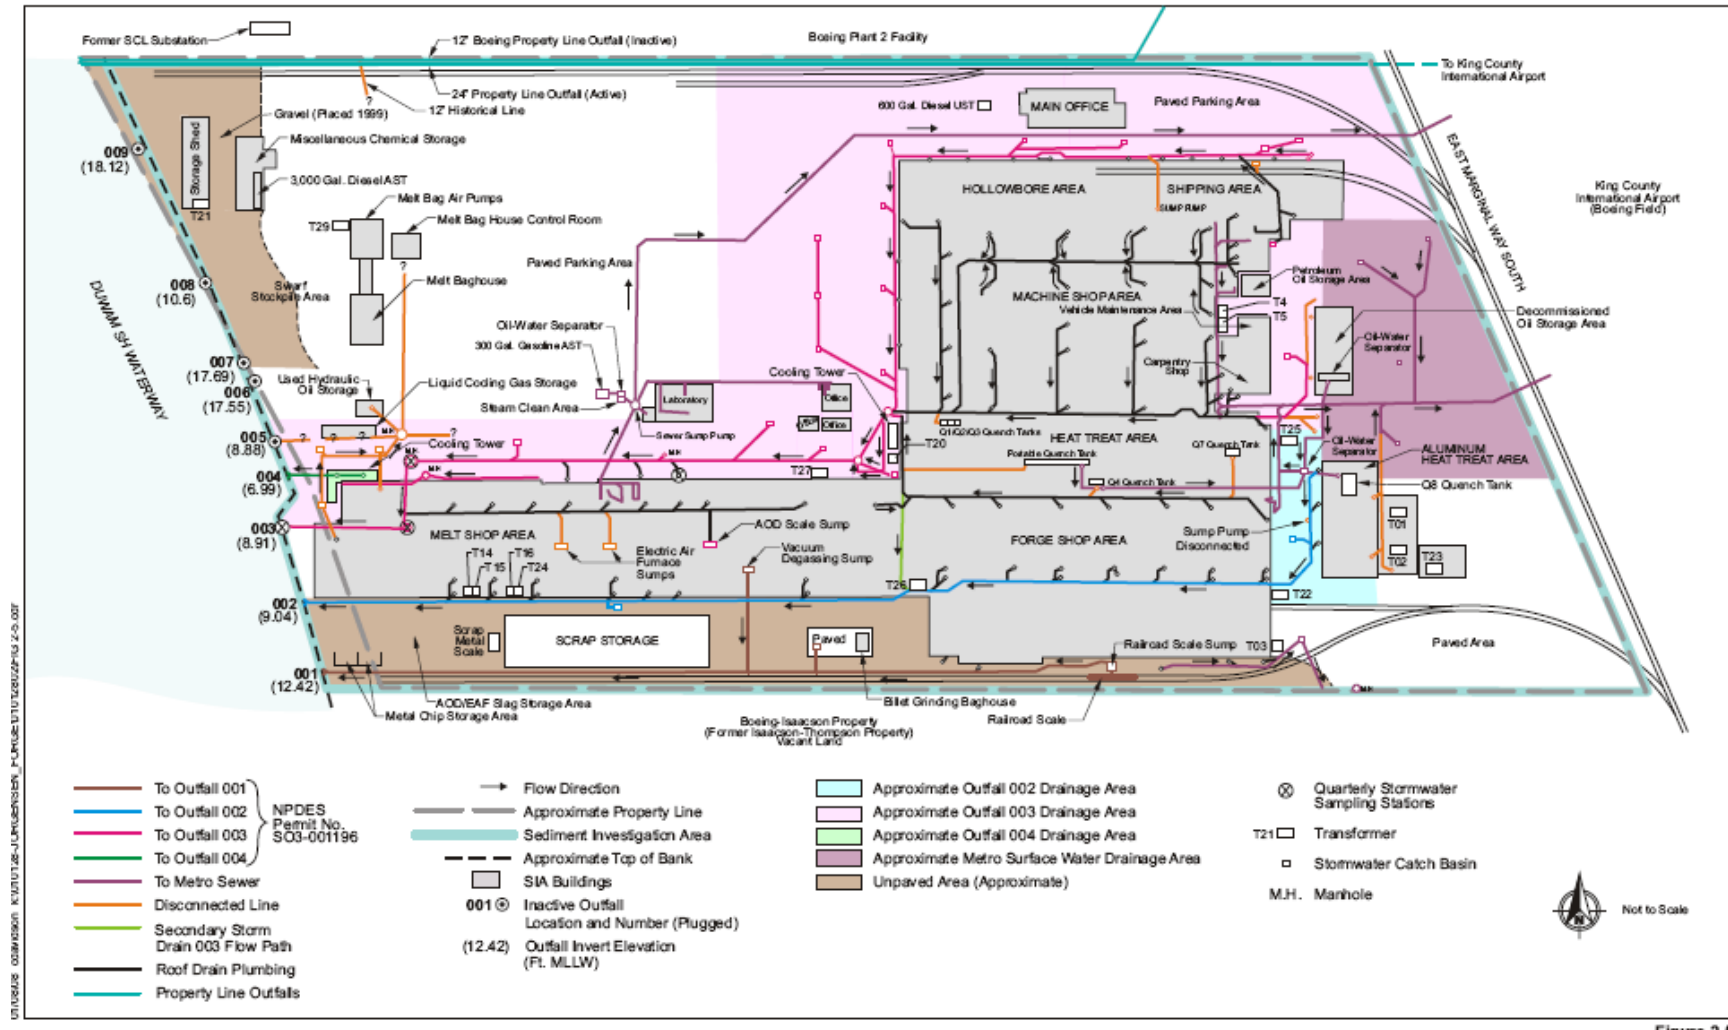
[Current Site Stormwater Drainage Plan, 2008 Draft Source Control Evaluation Report, Ecology Source Doc #3185, p. 275]

Stormwater runoff from the property discharges to the LDW subject to Jorgensen's NPDES Industrial Stormwater General Permit (No. SO3003231C). The stormwater conveyance system consists of 19 catch basins and underground piping that historically discharged and currently discharges to the LDW through permitted outfalls. The stormwater conveyance system captures stormwater runoff from impermeable surfaces, including paved areas outside the existing buildings, and the building roof drains. Surface water within the interior of the buildings is not captured or delivered in the stormwater collection and conveyance system. Historically, nine outfalls, identified as outfalls 001 through 009, existed on the facility and discharged stormwater to the LDW. Stormwater runoff from the eastern side of the property discharges to the King County Metro stormwater system [Data Summary Report, 616091, p. 14]. *See Figure Site Drainage.*

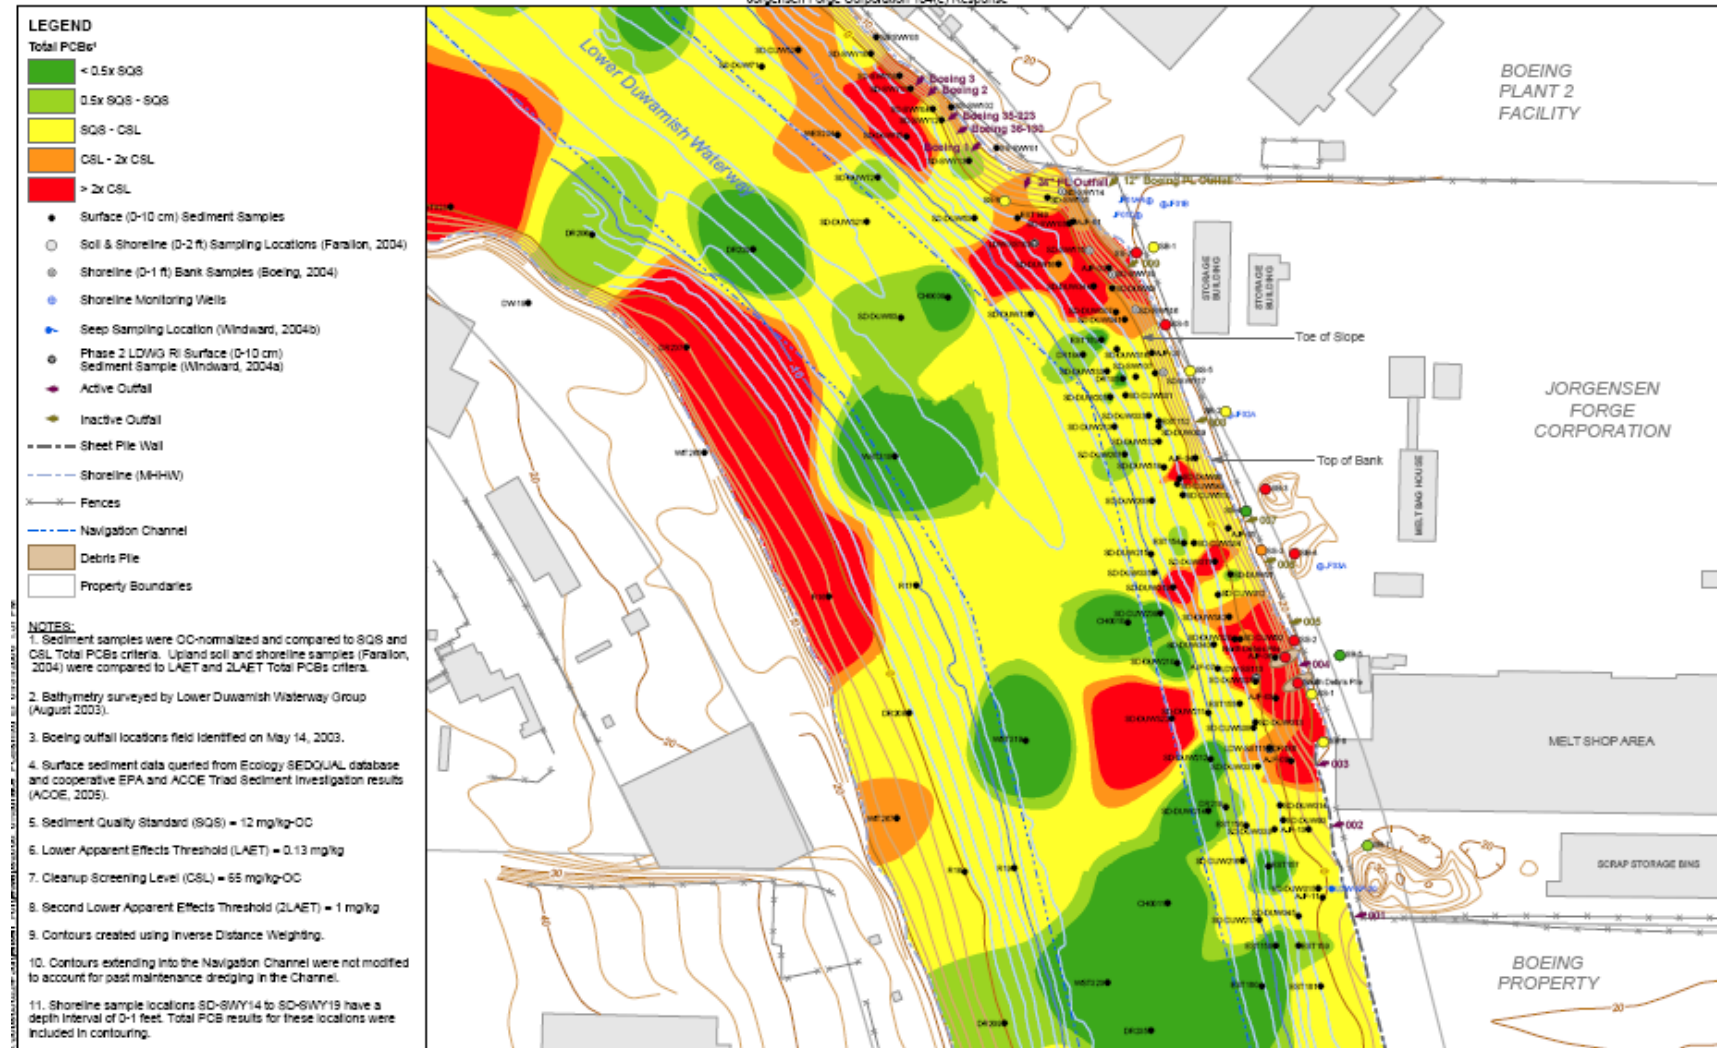
[Surface Sediment Contours-Total PCBs, 623093, p. 251]

Jorgensen's interpretation is that the results indicate there are no known current or past sources of PCBs associated with the EMJ and/or Jorgensen operations. PCBs and elevated concentrations of several metals have been detected in the subsurface fill (dredged from the Duwamish Waterway and placed on-site sometime between 1942 and 1946), debris piles along the bank, and sediments. The probable source of the PCBs to Duwamish Waterway sediments is discharged from the stormwater sewer lines located along the northern property boundary with Boeing Plant 2 and placement and subsequent erosion of PCB contaminated fill on-site. However, erosion of PCB contaminated fill and the debris piles may have contributed relatively minor amounts of PCBs and some of the metals may be due to past runoff from the Jorgensen Forge facility [2005 ESA, 623093, p. 25; 2008 Draft Source Control Evaluation Report, Ecology Source Doc #3185, p. 109]. *See Figures – Total PCBs in Soil, and Surface Sediment Contours - Total PCBs.*

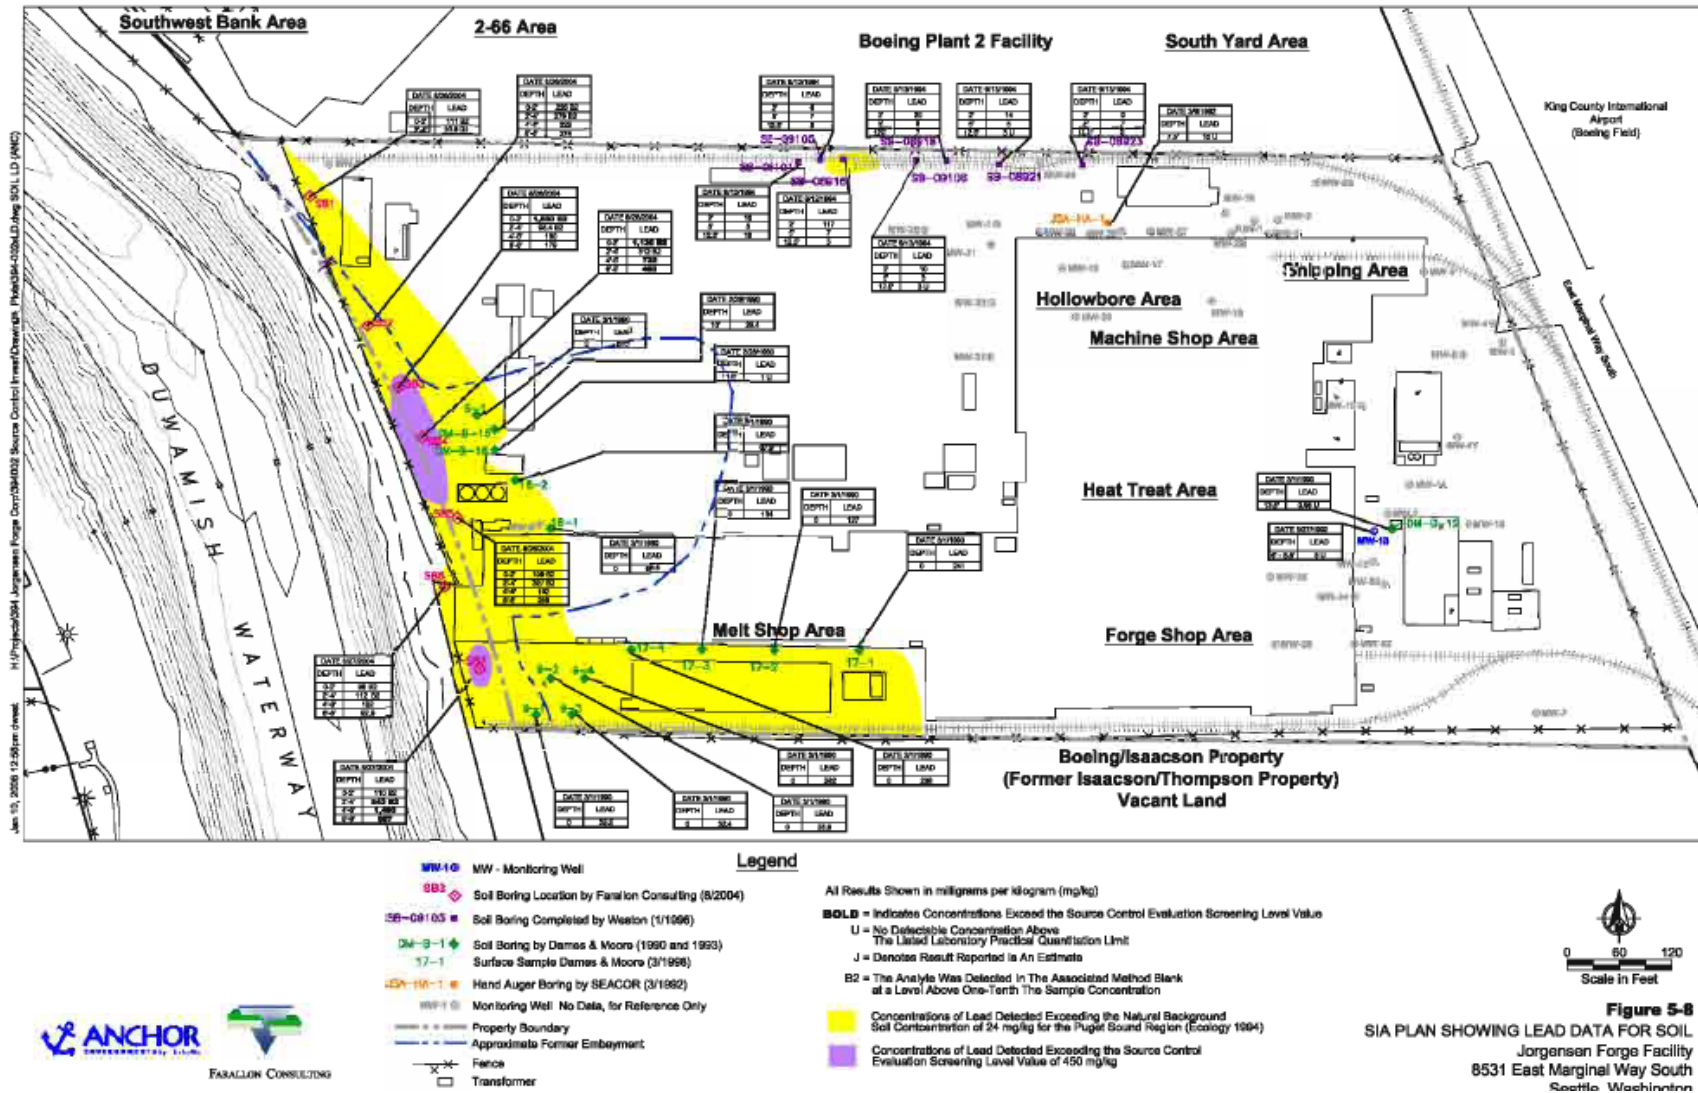
[Lead Data for Soil, 2008 Draft Source Control Evaluation Report, Ecology Source Doc #3185, p. 283]

- In *shoreline bank-face fill* samples, concentrations of PCBs ranged from 0.0255 to 4.54 mg/kg. All five samples exceeded the LAET of 0.130 mg/kg and two samples exceeded the 2LAET of 1 mg/kg. Arsenic concentrations ranged from 9.95 mg/kg to 64.9 mg/kg with one sampling exceeding the CSL. Cadmium exceeded SQS and CSL in all samples collected and chromium exceeded SQS and CSL in two samples. Copper exceeded its screening levels in one sample and lead exceeded the SQS and the CSL in four samples

ranging from 1,010 to 5,450 mg/kg [Data Summary Report, 616091, p. 26]. *See Figure Lead Data for Soil.*
